POPPLETON HISTORIC STUDY

B-2461

<u>Block</u>	<u>Lot</u>	<u>Address</u>
169	34-41	201-215 N. Carey Street

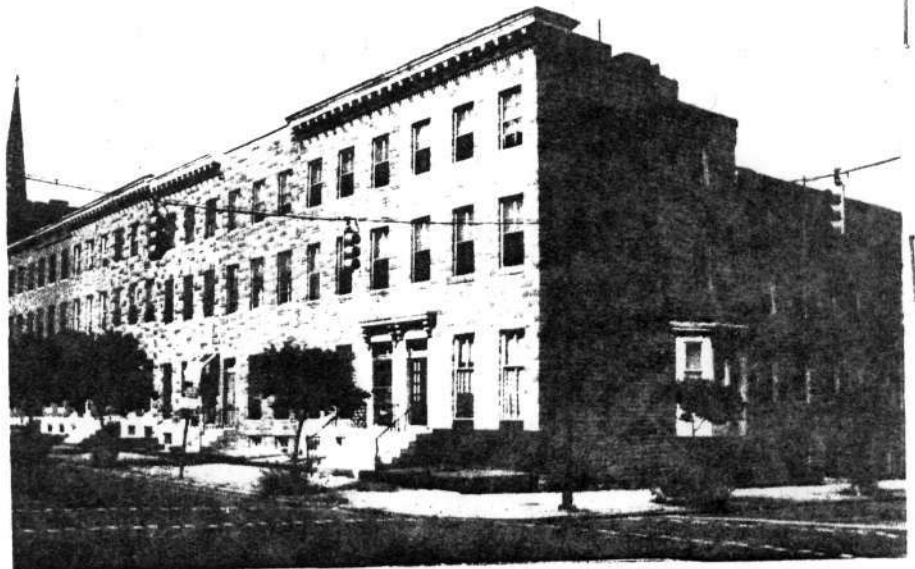
B-2461
201-215 N. Carey Street
Block 0169 Lots 034-041
Baltimore City
Baltimore West Quad.

The entire row has been formstoned except for number 213. These houses are of roughly the same date as those across Carey Street and north of them. All were built after the completion of St. Luke's Carey Street., i.e., 1865-1880. They appear on the 1876 map. This is an important group, apparently well maintained, although the formstone devalues their quality. They have marble steps, basements; numbers 201-207 have original iron work. The cornice line is somewhat damaged.

Good scale for the wide street; pleasant little street trees, if a bit small. Formstone is unfortunate in that it brings this group into too great contrast and prominence in relation to the church, to the north. The empty lot across the street is also in need of design. For visual relation to both the church and to Waverly Terrace across Saratoga Street, the formstone should be removed.
